EFFECTS OF ASPECT ON WEATHERING: ANOMALOUS BEHAVIOUR OF SANDSTONE GRAVESTONES IN SOUTHEAST ENGLAND

R. B. G. WILLIAMS* AND D. A. ROBINSON

School of Chemistry, Physics and Environmental Science, University of Sussex, Brighton, East Sussex, BN1 9QJ, UK

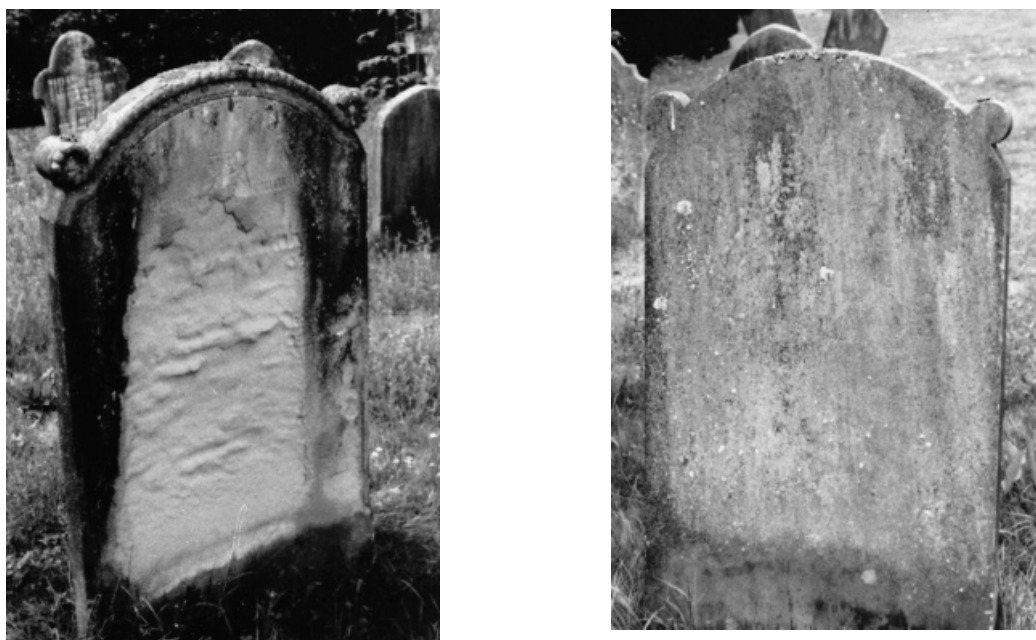
Figure 1. Victorian gravestone in Rusper churchyard (West Sussex) showing typical east–west weathering asymmetry. Left: the highly weathered east face has lost all trace of the original inscription. Right: the much less weathered west face. Note how the base, top and side edges of the stone are less weathered than the central portion

It is very noticeable in all the churchyards that the least damaged parts of the faces of headstones are the bases, and to a lesser extent the tops (Figure 1). The edges, including the top edge, also exhibit little damage. Generally, the faces of headstones are most deeply hollowed out at or just above their midpoint. However, in a significant minority, damage is greatest near the top of the face, especially if the upper edge of the stone is cut into a sharply pointed arch or bow.

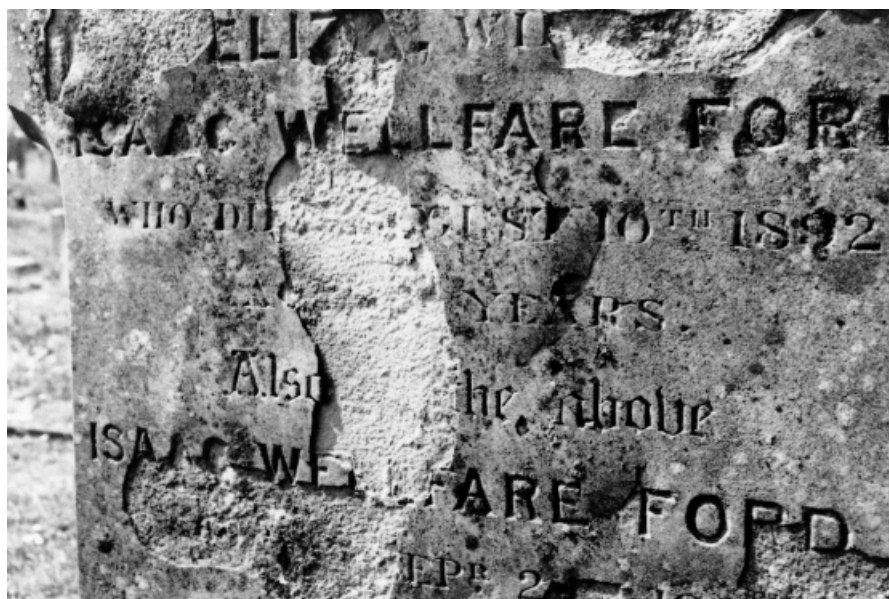
Figure 3. Surface spalling on an 1892 gravestone in Cuckfield churchyard

Despite developing a crust, the sandstone remains vulnerable to rapid breakdown under weathering attack (Figure 3). The crust easily detaches from the underlying rock and blister-like domes often develop as the crust bows out; these then rupture releasing spalls 1–4 mm thick, in a similar manner to the blisters that develop on limestone walls (Viles, 1993). In some cases the blisters are only a few tens of millimetres in diameter and are sharply defined, but sometimes a large section of the face lifts up as a gently curving sheet. Once the crust has been ruptured, the softer rock beneath is often rapidly consumed by multiple flaking and granular disintegration. The flaking does not appear to pick out original laminations in the rock and its causes are uncertain, though cycles of heating and cooling and/or wetting and drying may be responsible (Smith *et al.*, 1994). Individual flakes are often only one or two sand grains thick and very fragile. Although often associated with multiple flaking, granular disintegration also occurs in its absence.
